Manhole Inspection Summary

Manhole # S61K__021MH

Insp Date: **3/18/08 1:34 PM**

Location Address: **837 Tolna St.**

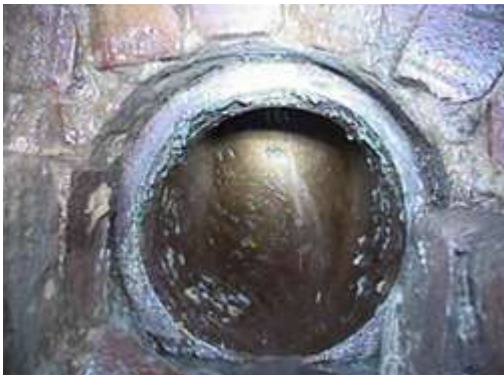
Defect 2

cracked pipe seal 11:00 incoming 9 O'Clock pipe

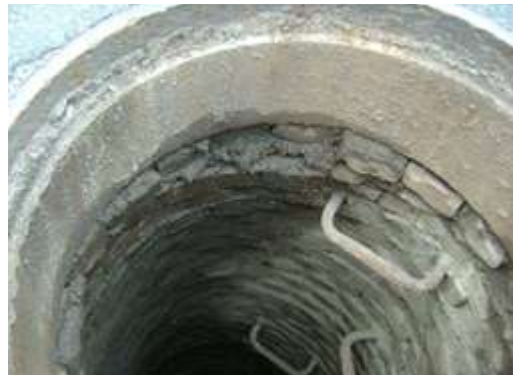
Defect 1

Condition: ☐ Sound ☐ Cracked ☐ Root Intrusion ☒ **Loose Brick** ☒ **Deteriorated**

Infiltration: ☐ None ☐ Joint ☒ **Cracks** ☐ Mortar ☐ Roots ☒ **Wall**

Infiltration at chimmney/frame joint due to missing mortar and loose bricks

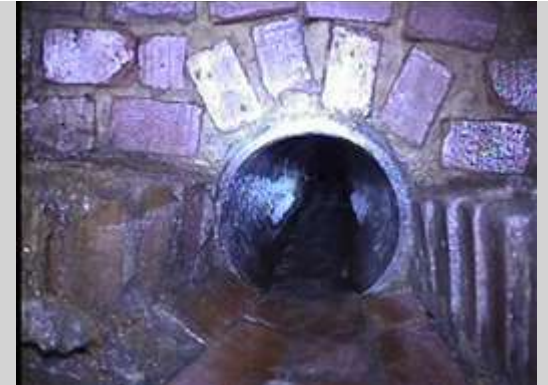
12 O'Clock Outflow

8 in. Circular Gravity Sewer
Pipe Out @ 12 O'Clock

Pipe Height: **8.4** (in.) Rod and Bar (Angled)
Pipe Material: **Clay** ☐ Pipe Lined
Invert Depth: **17.58** (ft.) Flow Characteristics: **Fast**
Deposits: ☒ None ☐ Mud ☐ Sludge ☐ Debris ☐ Grease
Silt Depth: (in.) Deposits Extent:
Infiltration: **None** Pipe Seal Cond: **Sound**

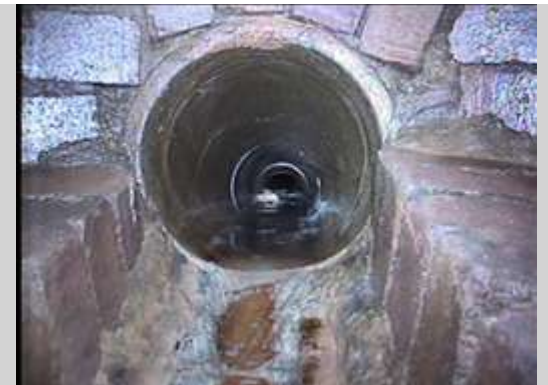
6 O'Clock Inflow

8 in. Circular Gravity Sewer
Pipe In @ 6 O'Clock

Pipe Height: **8.4** (in.) Rod and Bar (Angled)
Pipe Material: **Clay** ☐ Pipe Lined
Invert Depth: **16.75** (ft.) Flow Characteristics: **Fast**
Deposits: ☒ None ☐ Mud ☐ Sludge ☐ Debris ☐ Grease
Silt Depth: (in.) Deposits Extent:
Infiltration: **None** Pipe Seal Cond: **Sound**

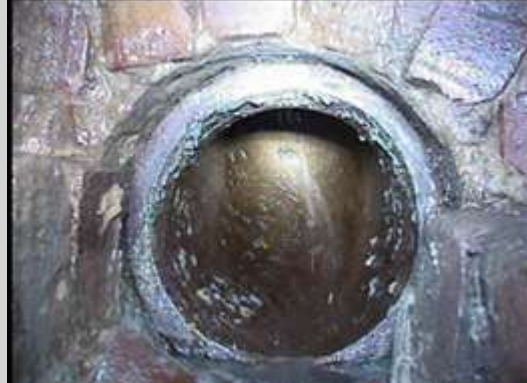
9 O'Clock Inflow

8 in. Circular Gravity Sewer

Pipe In @ 9 O'Clock

Infiltration: **None** Pipe Seal Cond: **Cracked**
